SEWRPC Staff Memorandum

POINT-INTERCEPT SURVEY FOR HONEY LAKE AND AQUATIC INVASIVE SPECIES MEANDER SURVEY OF IVANHOE LAKE, WALWORTH COUNTY, WISCONSIN

October 31, 2024

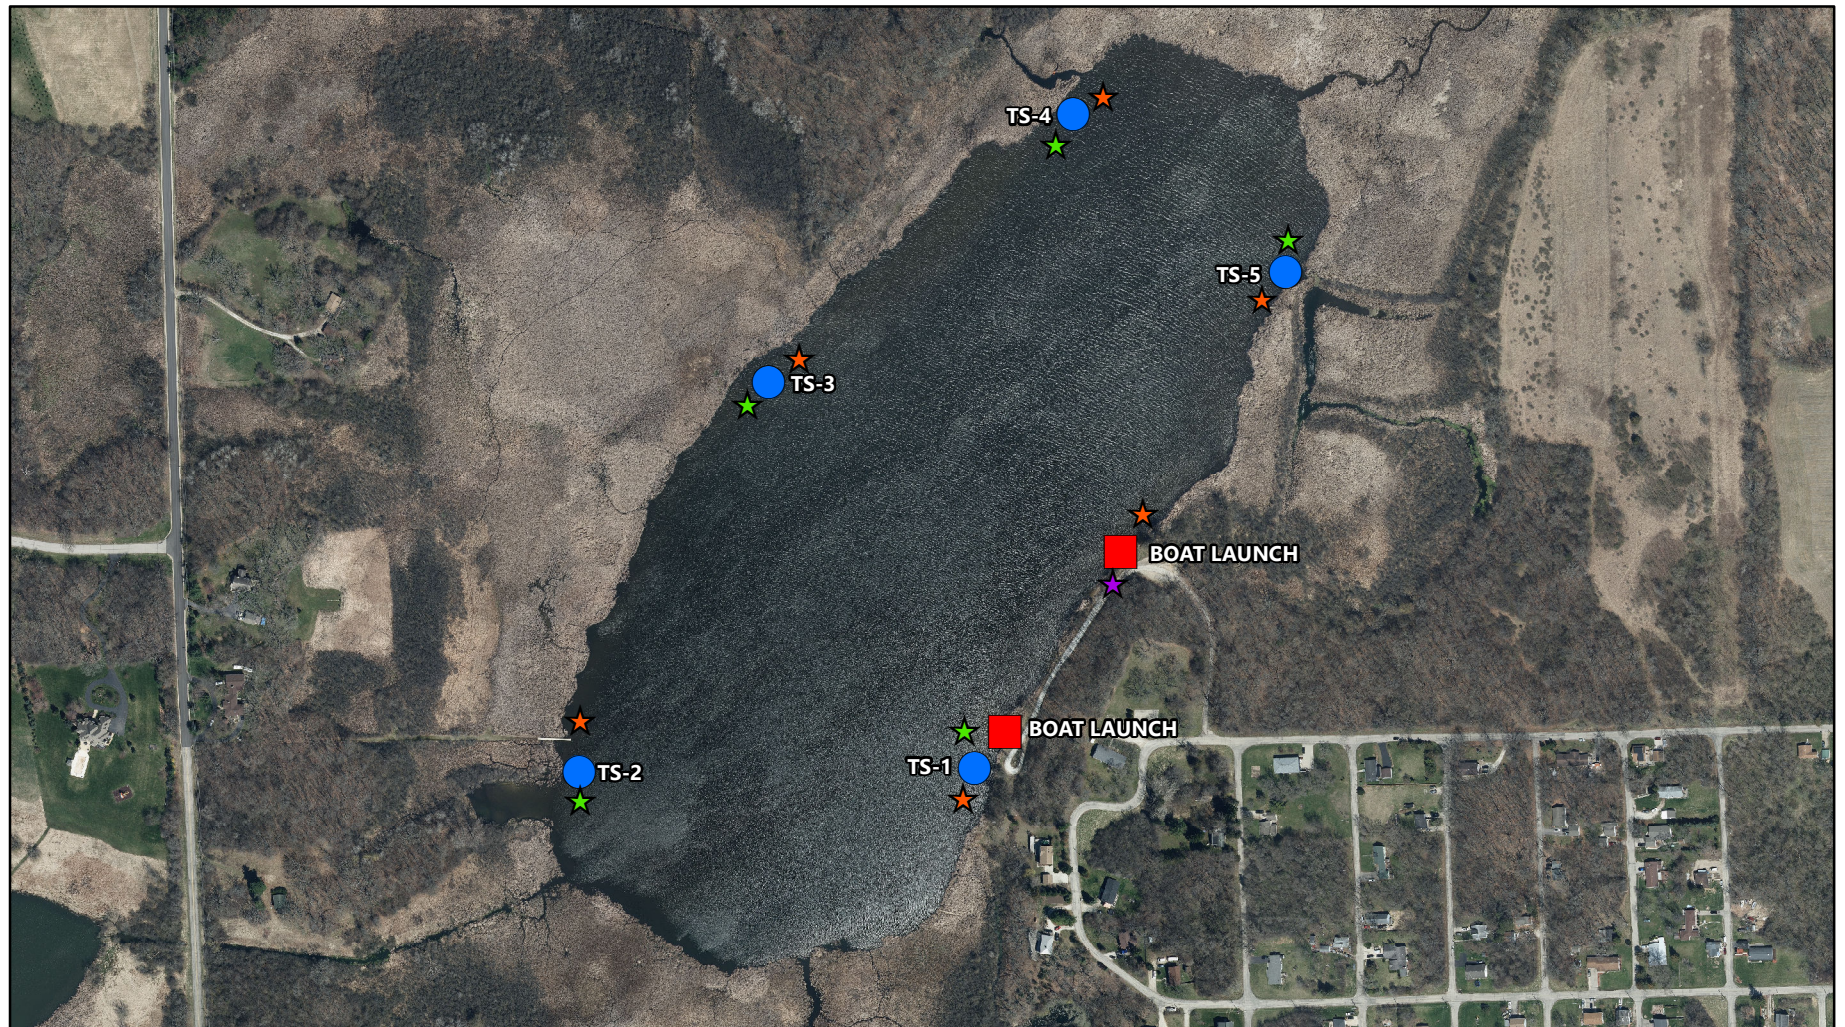
Figure 6
Meander Survey of Lake Ivanhoe: August 2024

Lake Ivanhoe water clarity was adequate with a secchi reading of 2.5 feet in depth. The water had a slightly murky orange appearance. Beginning with the boat launch, Commission staff conducted a clockwise meander of Lake Ivanhoe, noting incidences of native and invasive plant and animal species. Commission staff surveyed the lake using plant rakes and visual observations for the target sites and around the boat launch, as the soft, organic sediment made wading around the shoreline non-viable. Photos were collected

Two AIS were observed during the survey: Eurasian watermilfoil (*Myriophyllum spicatum*) and purple loosestrife (*Lythrum salicaria*). Eurasian watermilfoil was growing in dense mats throughout much of the lake with leaves and flowers breaking the water's surface. Purple loosestrife was found near the main boat launch on Lake Ivanhoe. No invasive mussels or snails were observed in the Lake. Observations of purple loosestrife had not been previously recorded on the WDNR webpage for the Lake nor on the published list of waterbodies with these AIS species.^{10,11} However, purple loosestrife was noted on a 2008 point-intercept survey completed by WDNR. Commission staff submitted these new AIS observations to the WDNR.

Note: Aquatic invasive species locations are generally marked and are not meant to represent the exact location each species was observed.

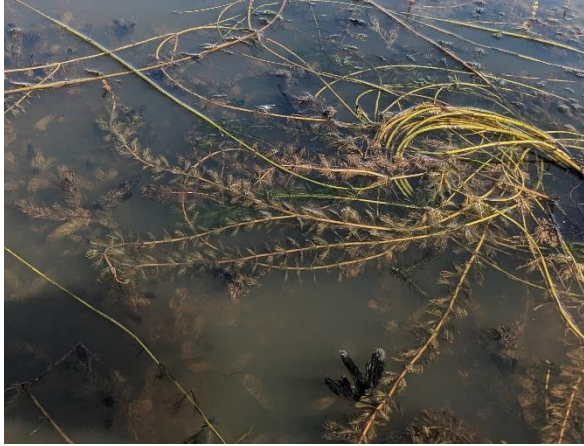
Eurasian Water Milfoil

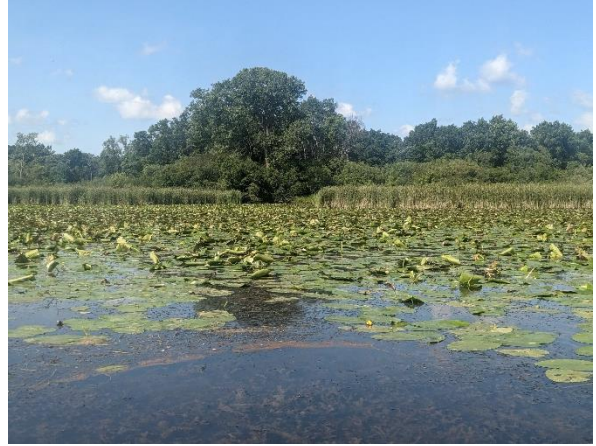
Lake Ivanhoe's aquatic plant community has been regularly monitored since 2005 with a complete point-intercept survey being conducted each year up to 2022. These surveys provide an excellent timeline for invasive species population in the lake (Figure 8). Lake Ivanhoe has a fairly diverse community of plant with many surveys finding up to of 13 plant species. Several native aquatic plant species were observed during the Lake Ivanhoe meander survey including species that are beneficial to the lake's ecology. Spatterdock and white water lily were observed across much of the lake's near shore area.

Spatterdock, White water-lily, & Hybrid cattails

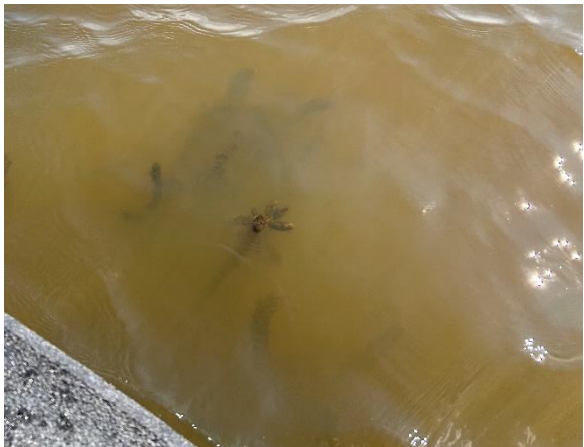
Watercolor as viewed from boat

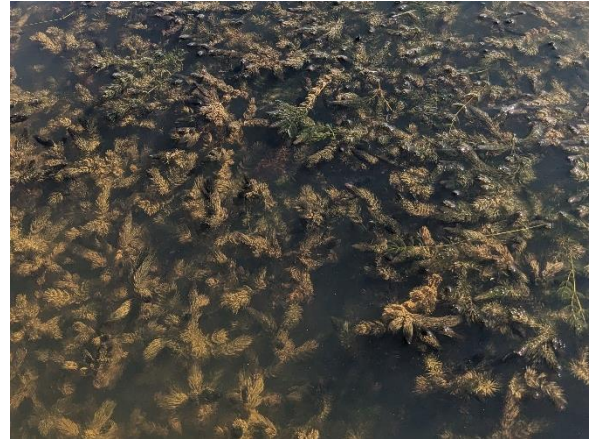
Coontail
